**CULTURAL RESOURCES SURVEY OF THE PROPOSED CHEVRON
PHILLIPS CHEMICAL COMPANY LP U.S. GULF COAST (USGC)
PETROCHEMICALS PROJECT IN [REDACTED],
BRAZORIA COUNTY, TEXAS**

SWCA Project Number 21457.01

SWCA Cultural Resources Report No. 2013-162

August 5, 2014

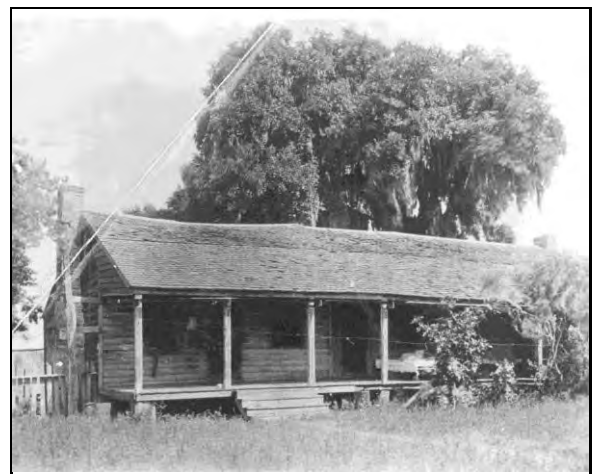
outbuildings. The original house (Resource ID 1a), a side-gabled dogtrot with inset full-width front porch, was constructed in 1837 of cypress and ash (**Figure 7-8**). In 1947, the house was rebuilt in the same location, possibly salvaging the two exterior gable wall chimneys (**Figure 7-9**). At the time of the rebuilding, a cross gabled second story addition was added and the front porch was enclosed with jalousie windows. Presently, the house is abandoned and in poor condition.

Figure 7-8. South façade of the Sweeney Jr. Plantation house, pre-1947, north view. Image courtesy of Brazoria County Historical Museum.

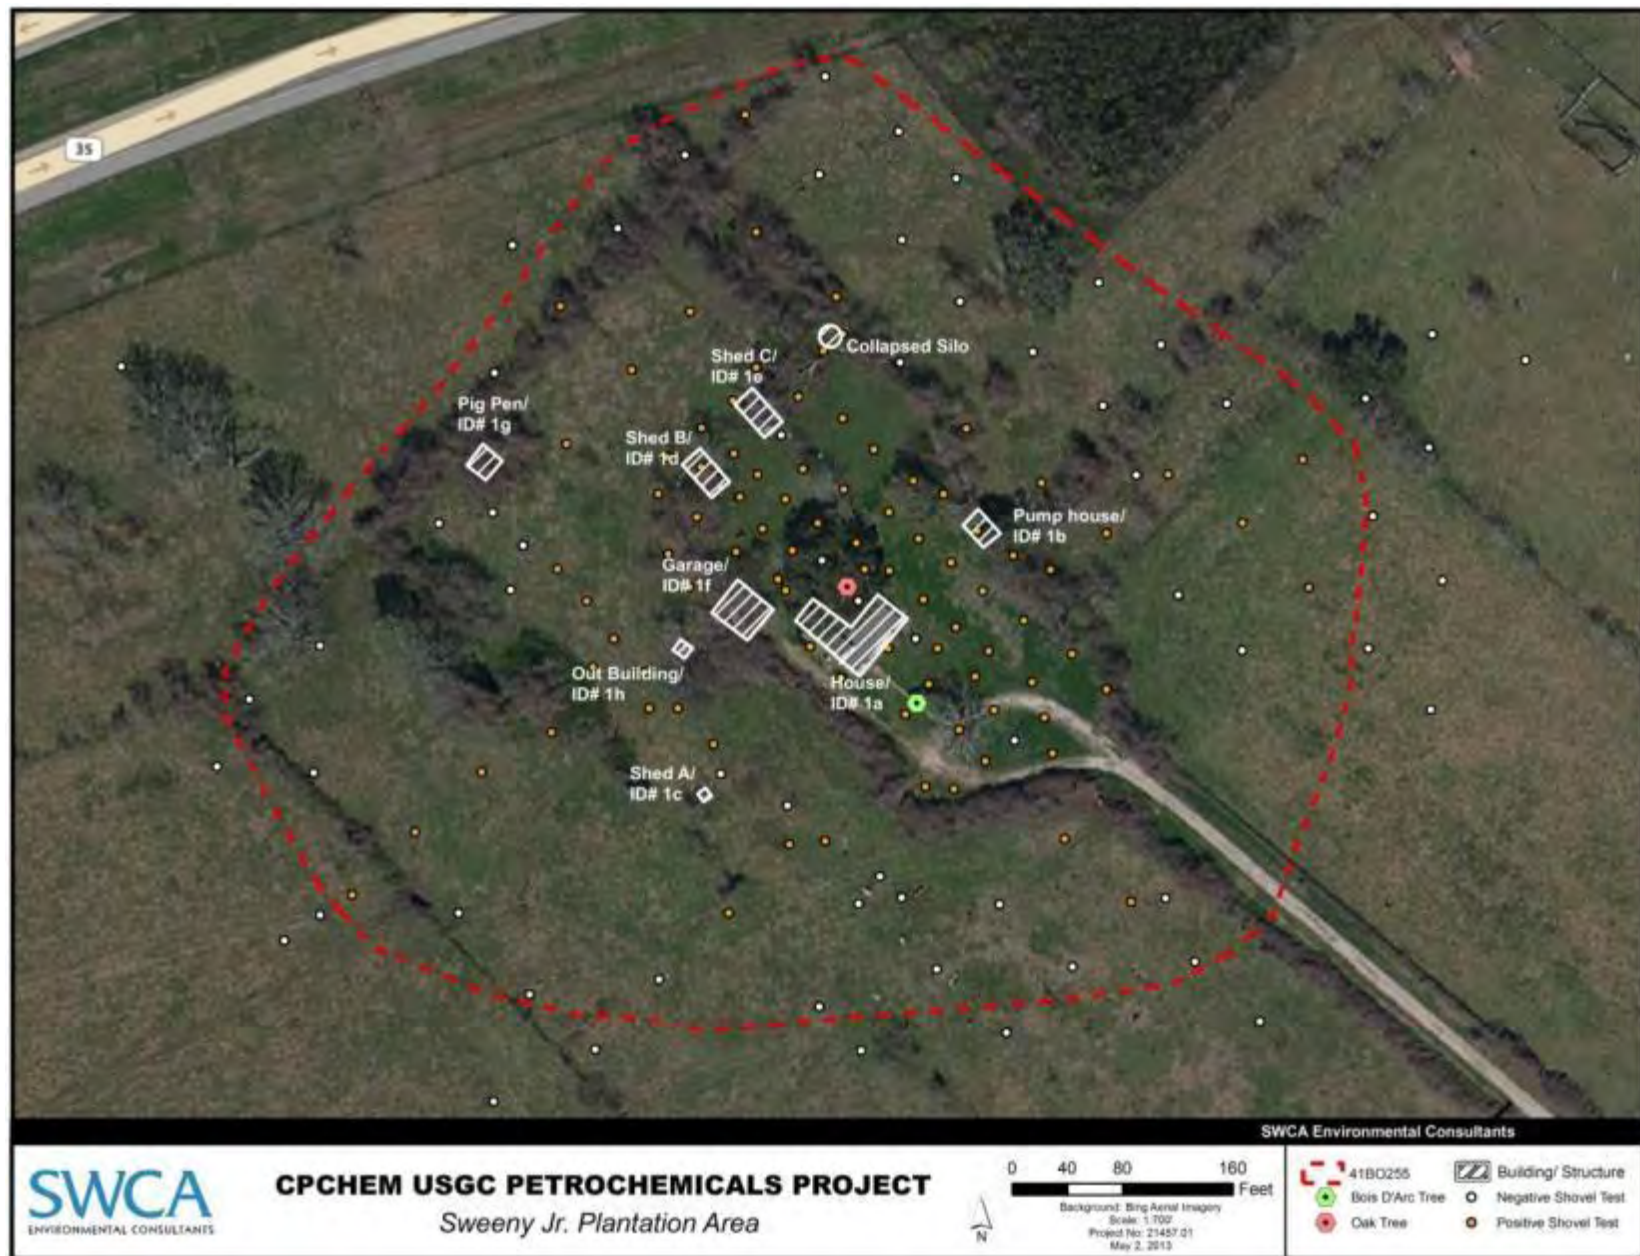
Figure 7-17. Shovel tests excavated at site 41BO255.

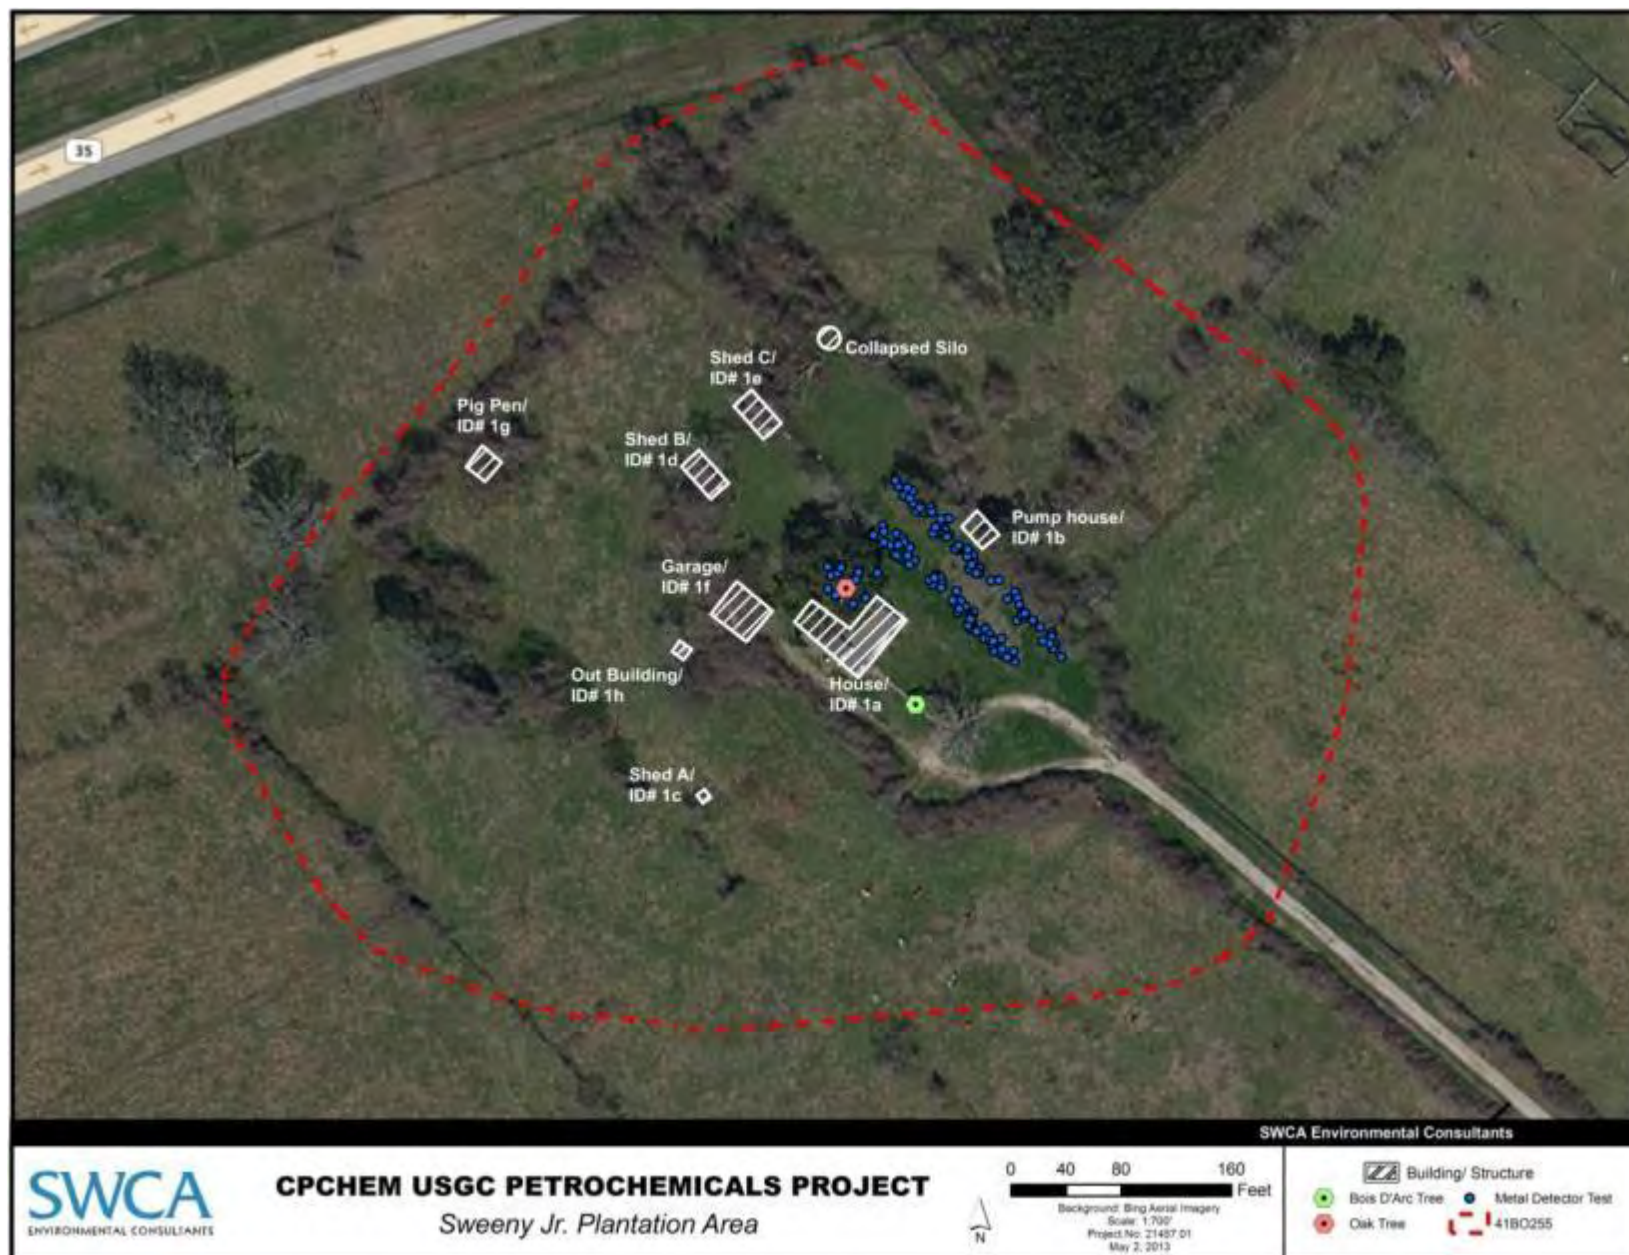
Figure 7-18. Location of positive metal detecting hits.

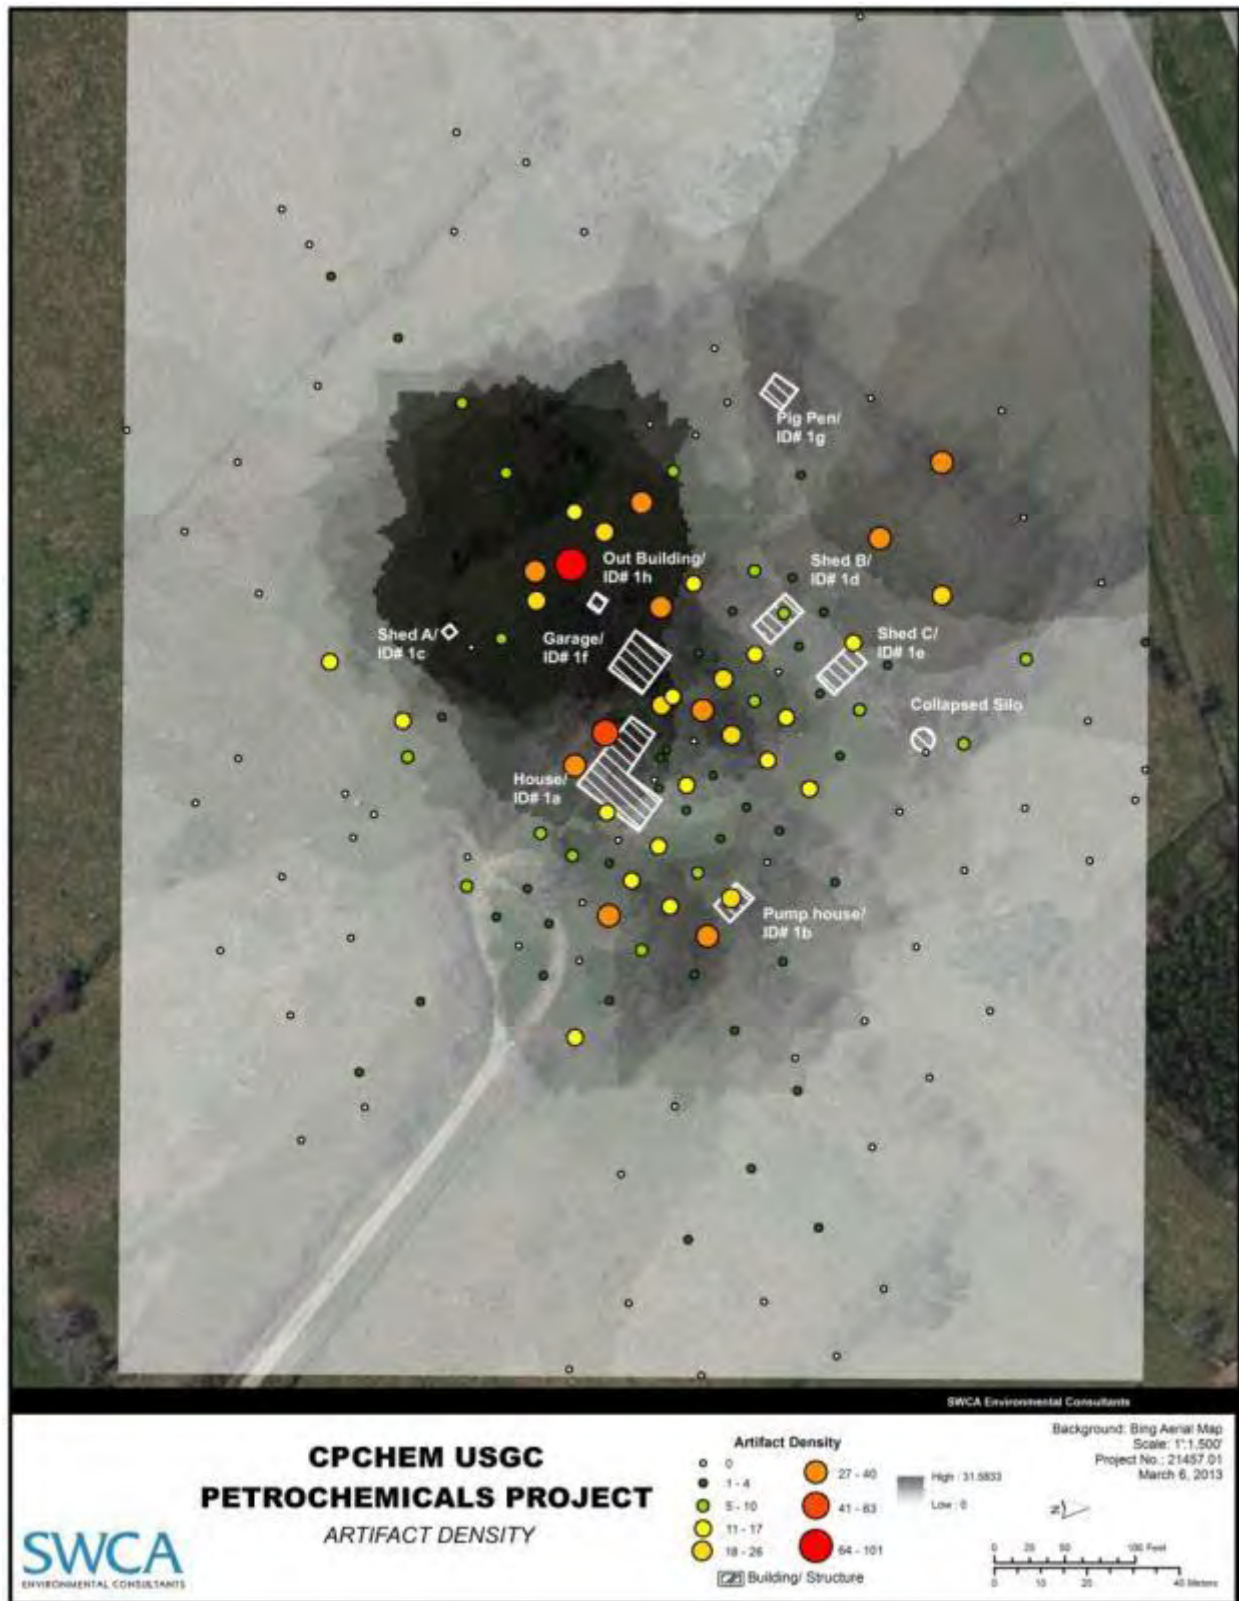
Figure 7-19. Artifact density plot for site 41BO255.

In order to better assess the composition and integrity of archaeological deposits, as well as locate features indicated to have been present at the site, SWCA recommends Phase II significance testing at site 41BO255. The testing should specifically target those areas with high artifact densities as indicated in **Figure 7-19**, and at those locales where artifact types and densities suggest the presence of kitchen or refuse middens. Furthermore, testing of surfaces beneath the c. 1947 structures may encountered better-preserved archaeological deposits and may expose one or more of the aforementioned plantation-era features.

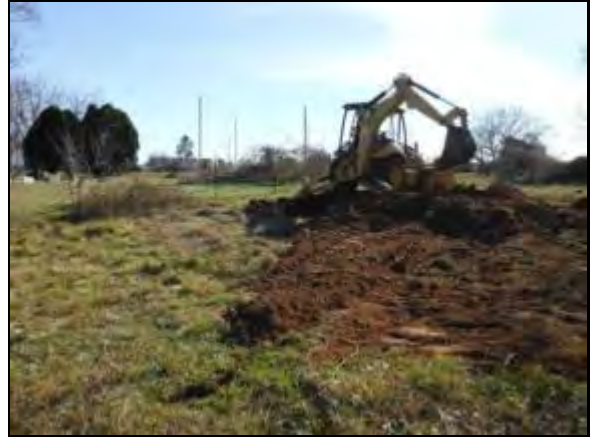
To further investigate the anomalies identified along the northwestern-facing fence line, mechanical scraping was employed along the northwestern border of the cemetery. A swath of land approximately 22-m (75-feet) long was scraped with a backhoe from west to east in six inch increments to a depth of three feet (**Figure 7-25**). The location was mapped and the soils recorded. Soils encountered during scraping exhibited one stratum in profile which extended from the ground surface to a depth of 36 inches and consisted of very dark gray (10YR3/1) silty clay.

Figure 7-25. Mechanical scraping at the Sweeny Cemetery, southwest view.

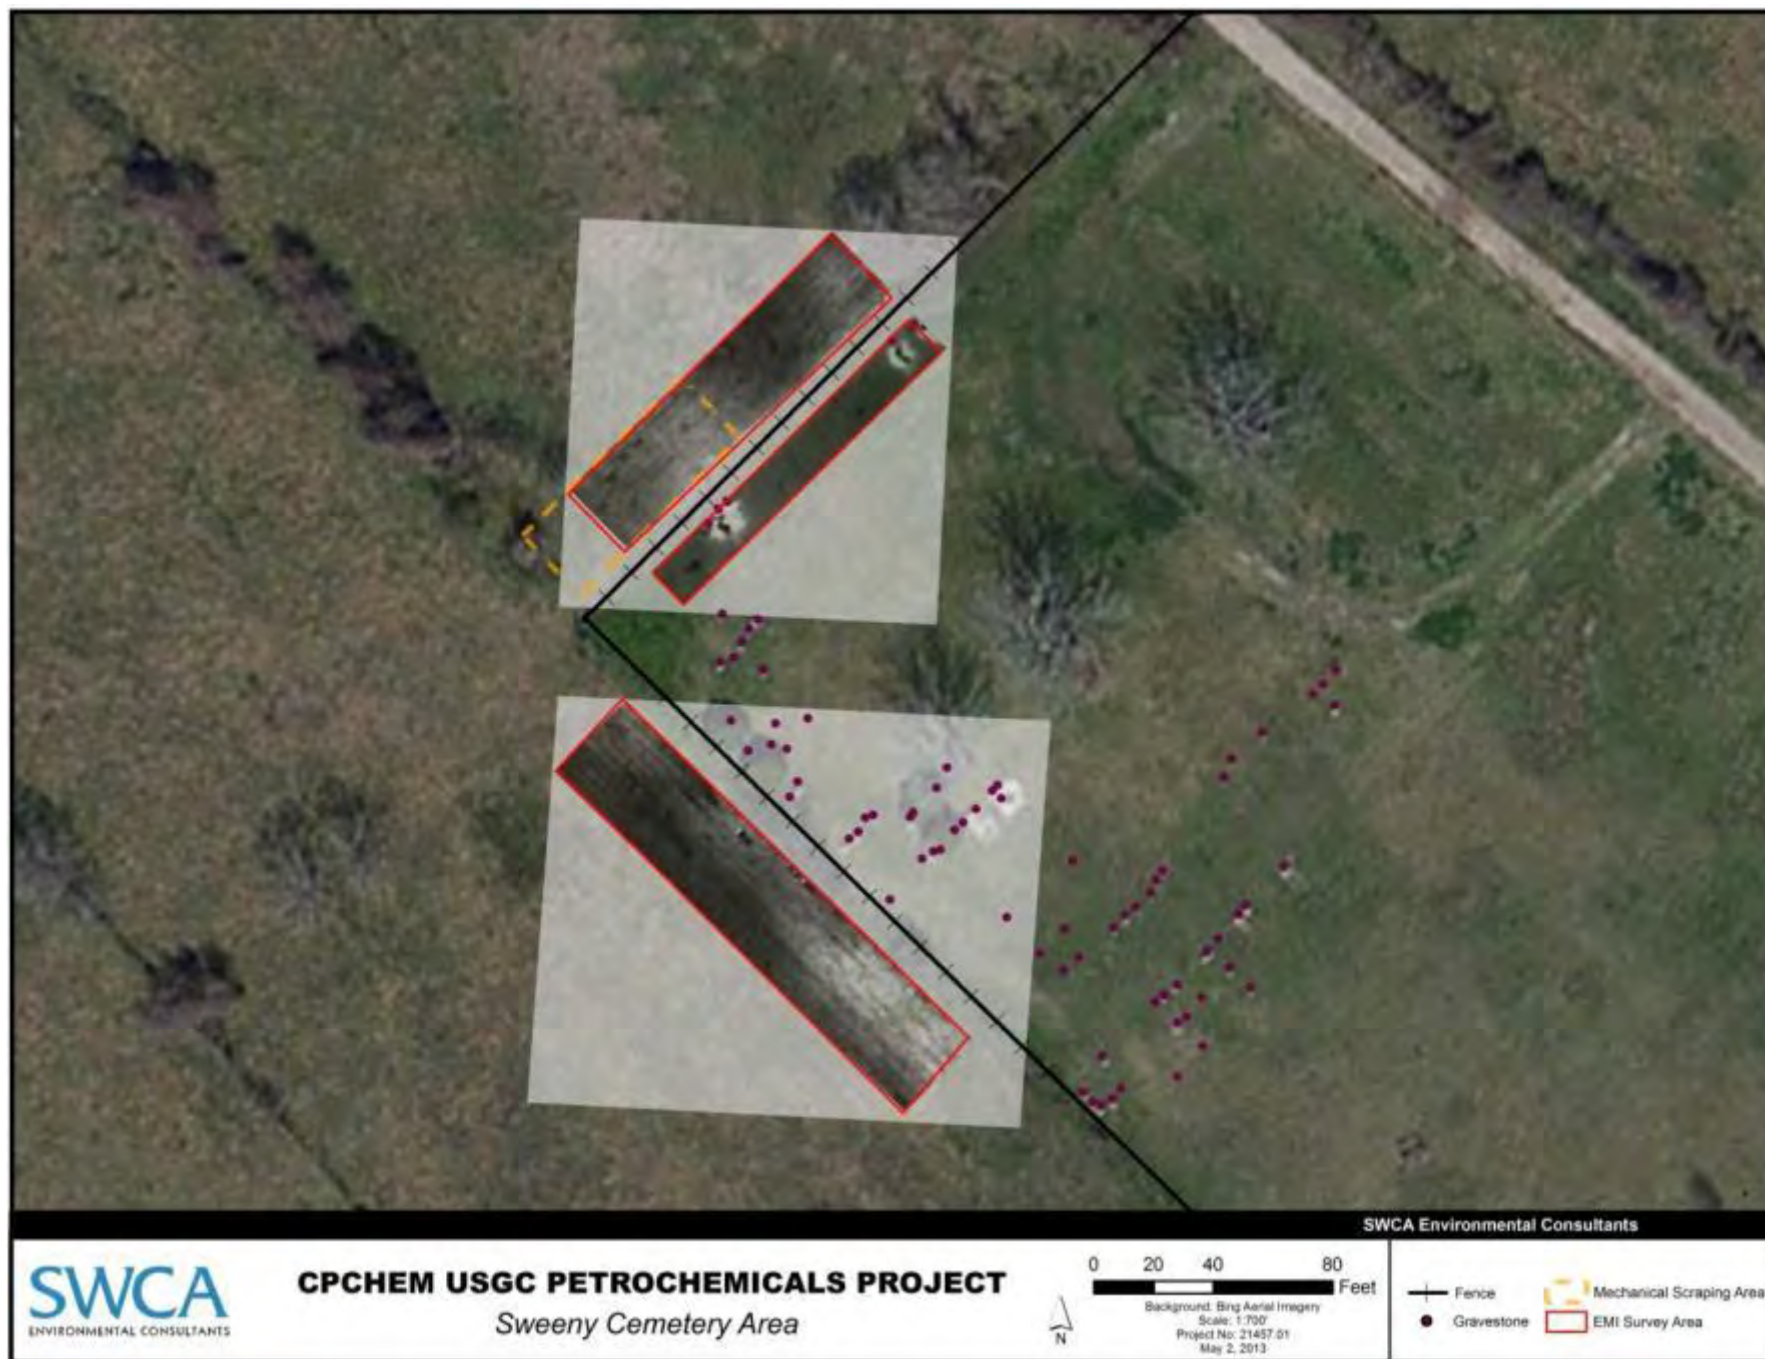
Figure 7-26. Aerial overview of the Sweeny Cemetery depicting the geophysical survey results, mechanical scraping areas, and grave markers.

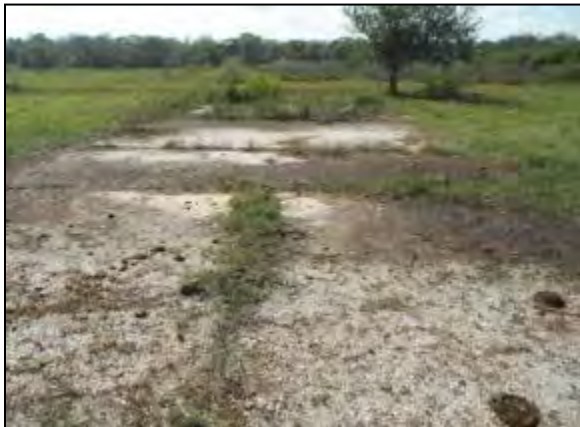
(Figure 7-7; Appendix D: D-2). The site measures approximately 300 x 350 m (984 x 1148 feet) and includes an 8-x-8-foot cast-concrete basin, concrete rubble and footings, a concrete and gravel foundation, and an oyster and gravel drive (Figures 7-29 and 7-30).

Figure 7-29. Concrete and gravel foundation pad identified at site 41BO245, southwest view.

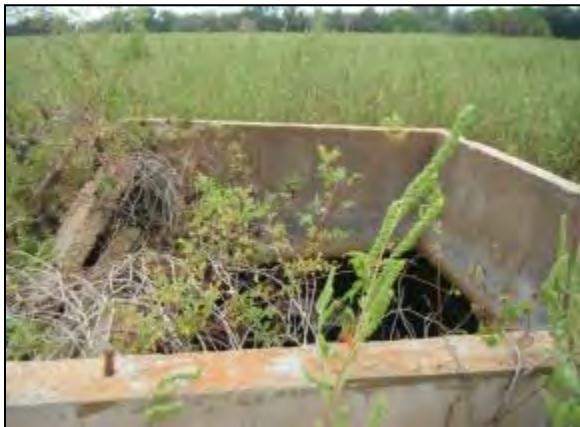
Figure 7-30. Concrete basin identified at site 41BO245, east view.

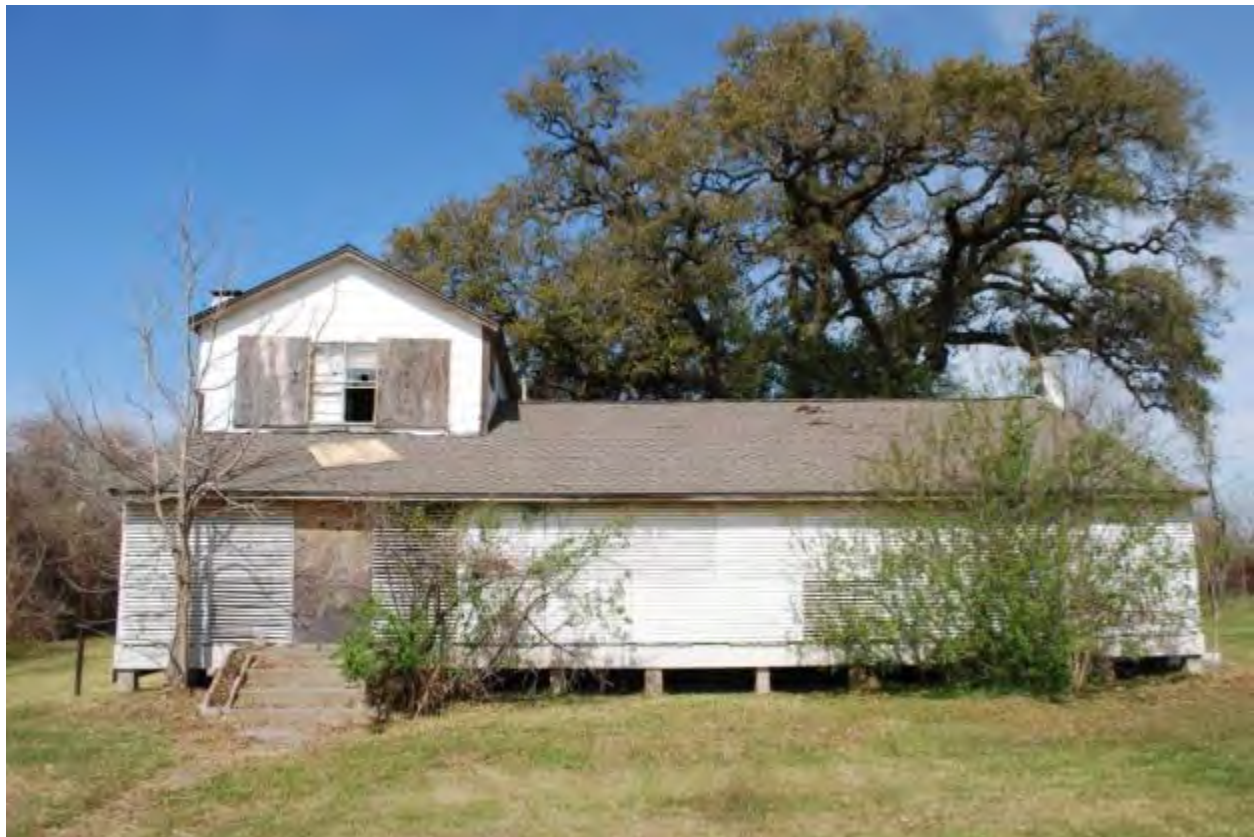
Comments: The original house, a side gabled dog trot with inset full width front porch, was constructed in 1837 of cypress and ash. In 1947 the house was rebuilt in the same location possibly salvaging the two exterior gable wall chimneys. At the time of the rebuilding, a forward facing gabled second story over the main entrance area and the front porch was enclosed with jalousie windows.

ID 1a: South facade, John Sweeny, Jr. Plantation house, view north

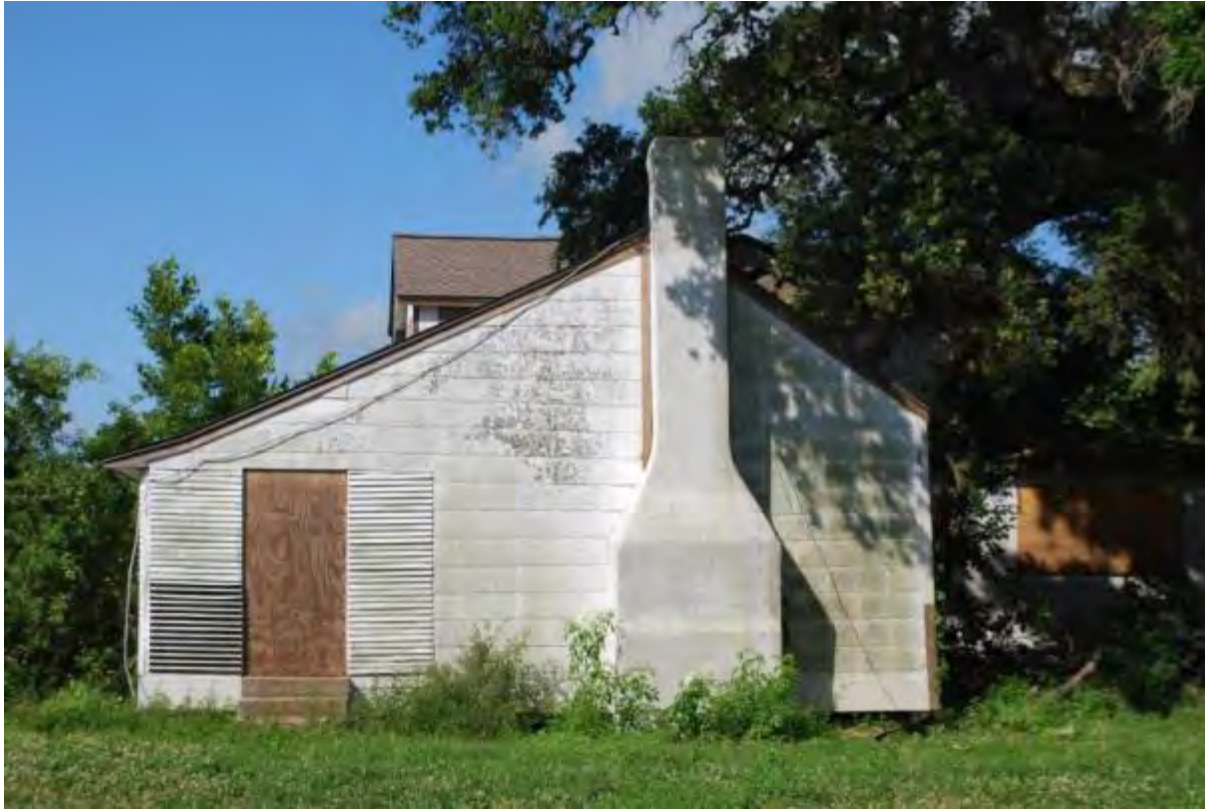
ID 1a: East elevation, John Sweeny, Jr. Plantation house, view west

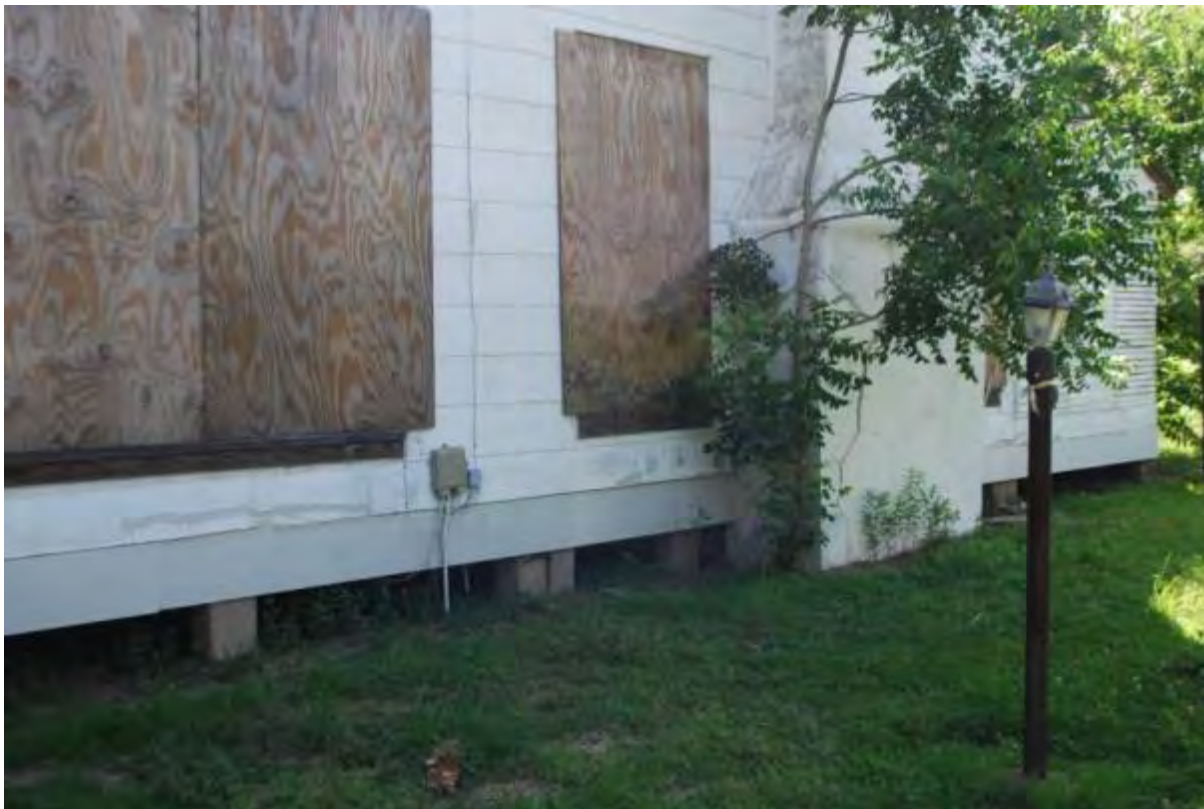
ID 1a: Detail of west elevation chimney and foundation piers, view southeast

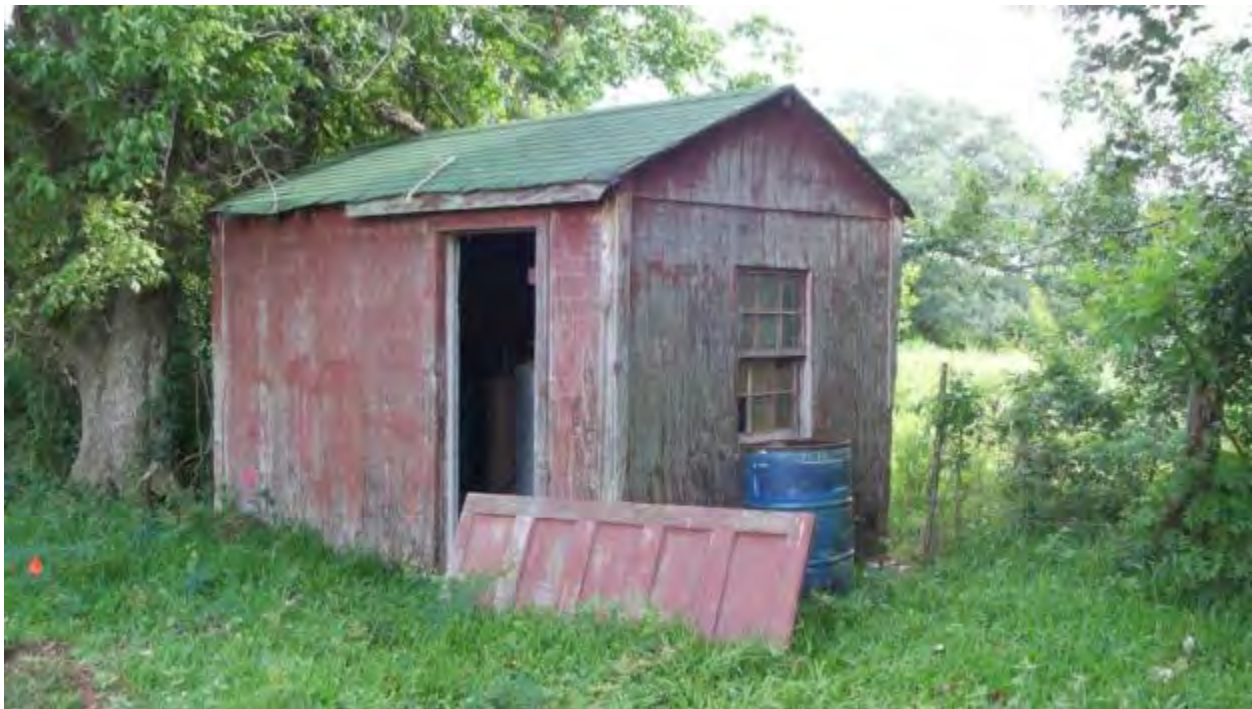
Comments: Side gabled, wood framed structure with 6/6 wooden sash window in gabled end and single entry five paneled door on non-gabled elevation. Siding is T-111 pressed board; roof is asphalt shingles.

ID 1b: Pump house, view northwest

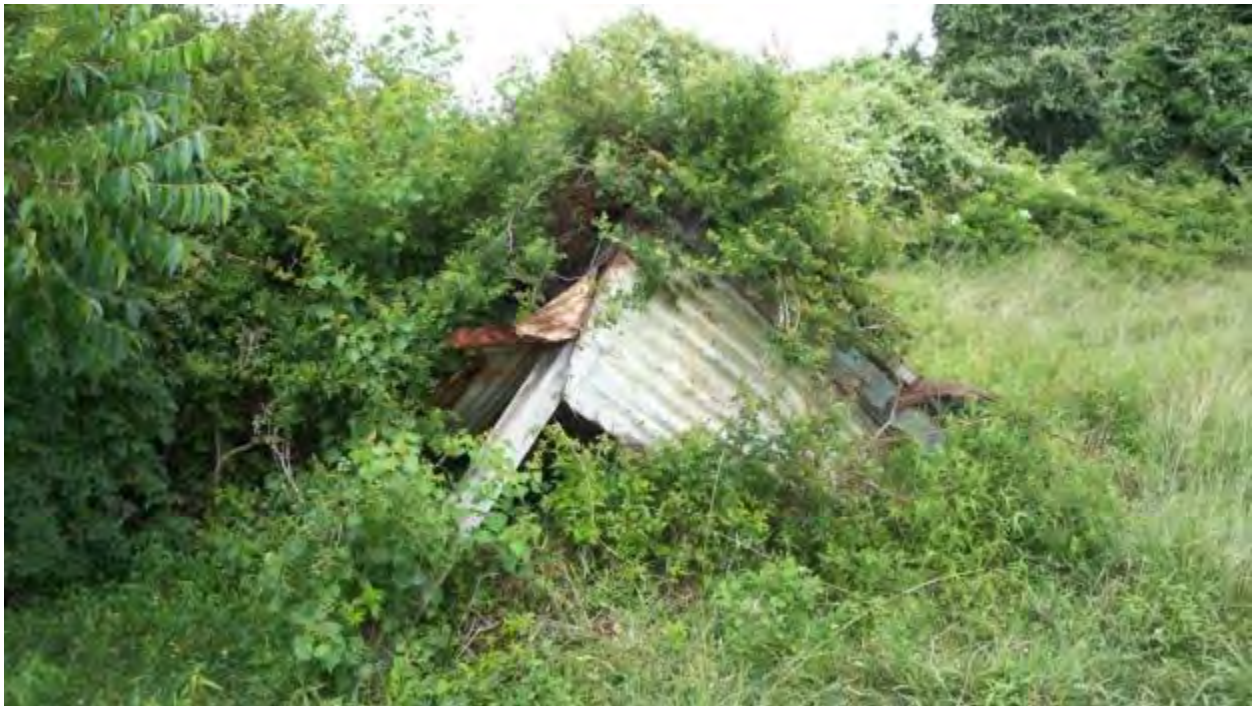
Comments: ID 1c (Shed A) is a collapsed wood framed shed with corrugated metal siding and roof.
ID 1d (Shed B) is wood framed, side gabled an open air shed with enclosed tool shed on north end. Siding and roof is corrugated metal.
ID 1e (Shed C) is a wood framed, side gabled open air shed with vertical corrugated metal siding in gable ends. Interior demising wall also metal.

ID 1c: Shed A - collapsed

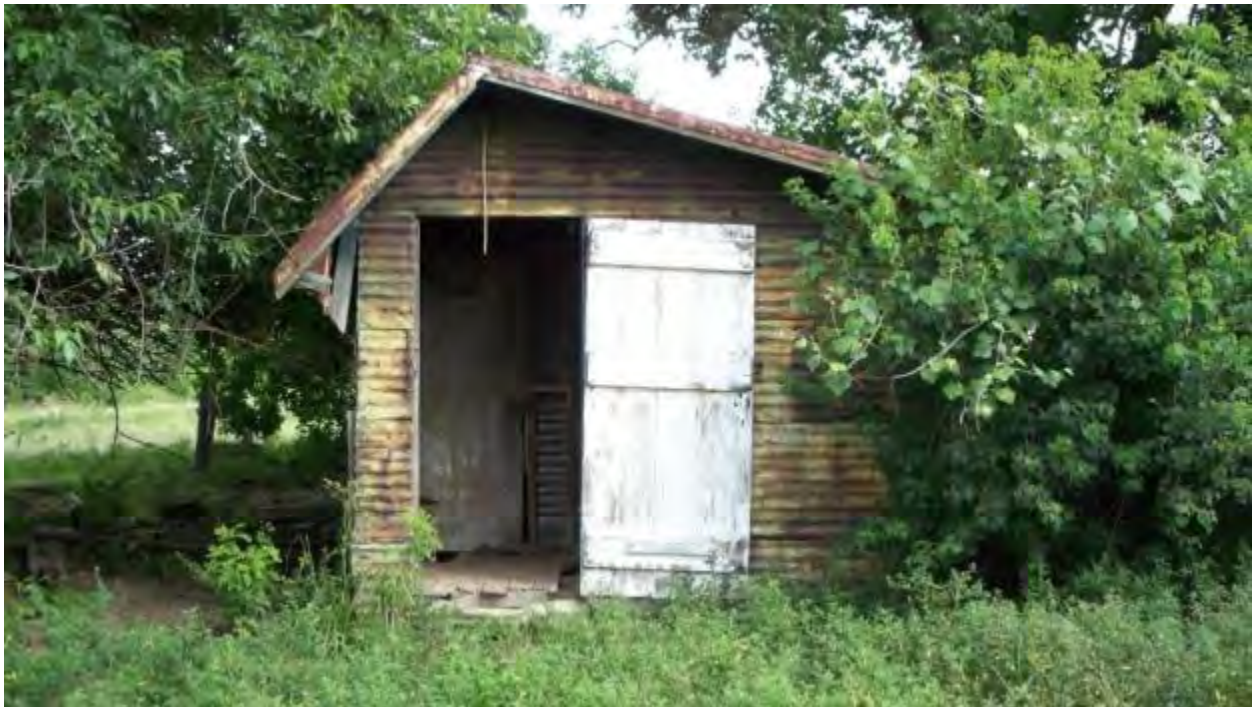
Rectangular plan, wood framed corrugated metal outbuilding

ID 1h: Unidentified building, east elevation, view west

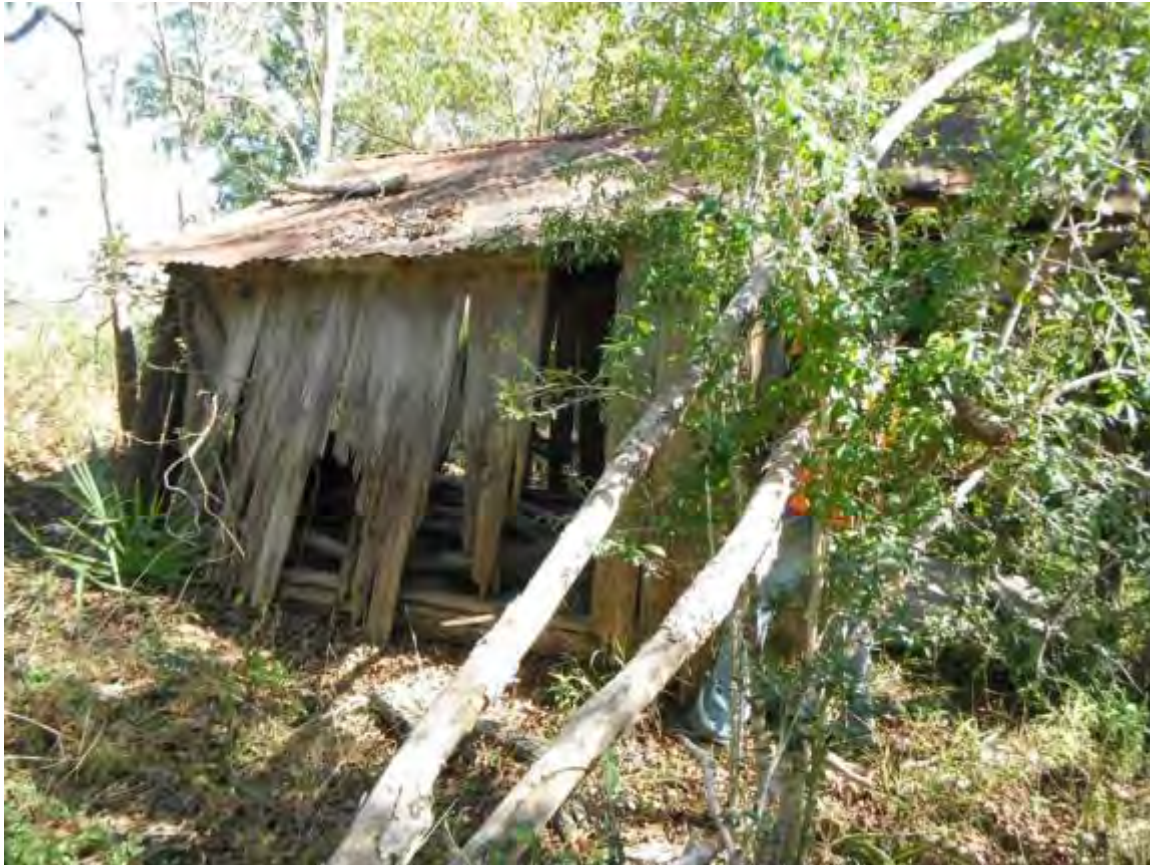
Comments: Small, 10x10 wood framed shed clad with vertical machine milled boards and topped with a gabled, corrugated metal roof. There are remnants of interior wood flooring. There is a carport extension off of the exterior, possibly used to shelter a tractor.

ID 2: West elevation, Agricultural outbuilding, view E

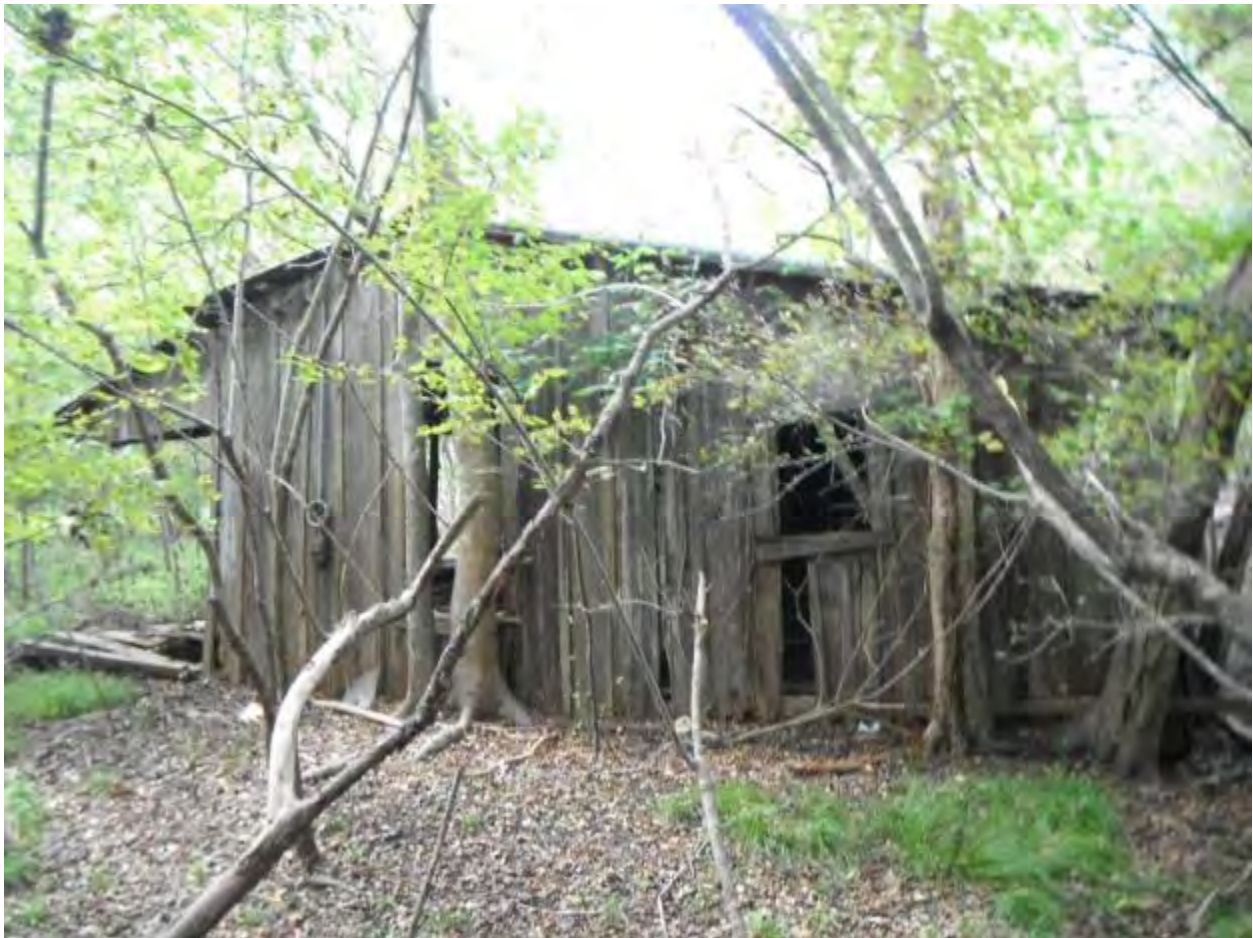
Comments: Wood framed, side gabled bunkhouse with board and batten siding and a corrugated metal roof. Full width porch roof is extant. The interior is divided into at least three rooms each with exterior access.

ID 3: East elevation, Multi-family bunkhouse, view SW

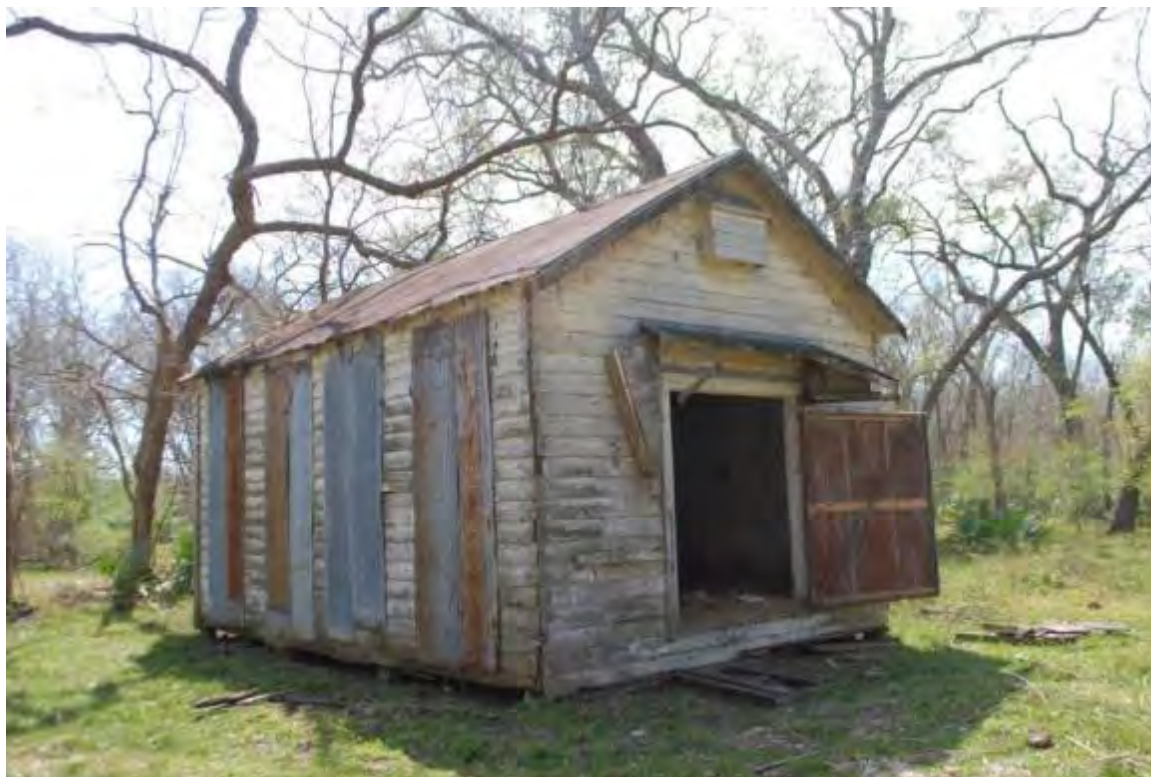
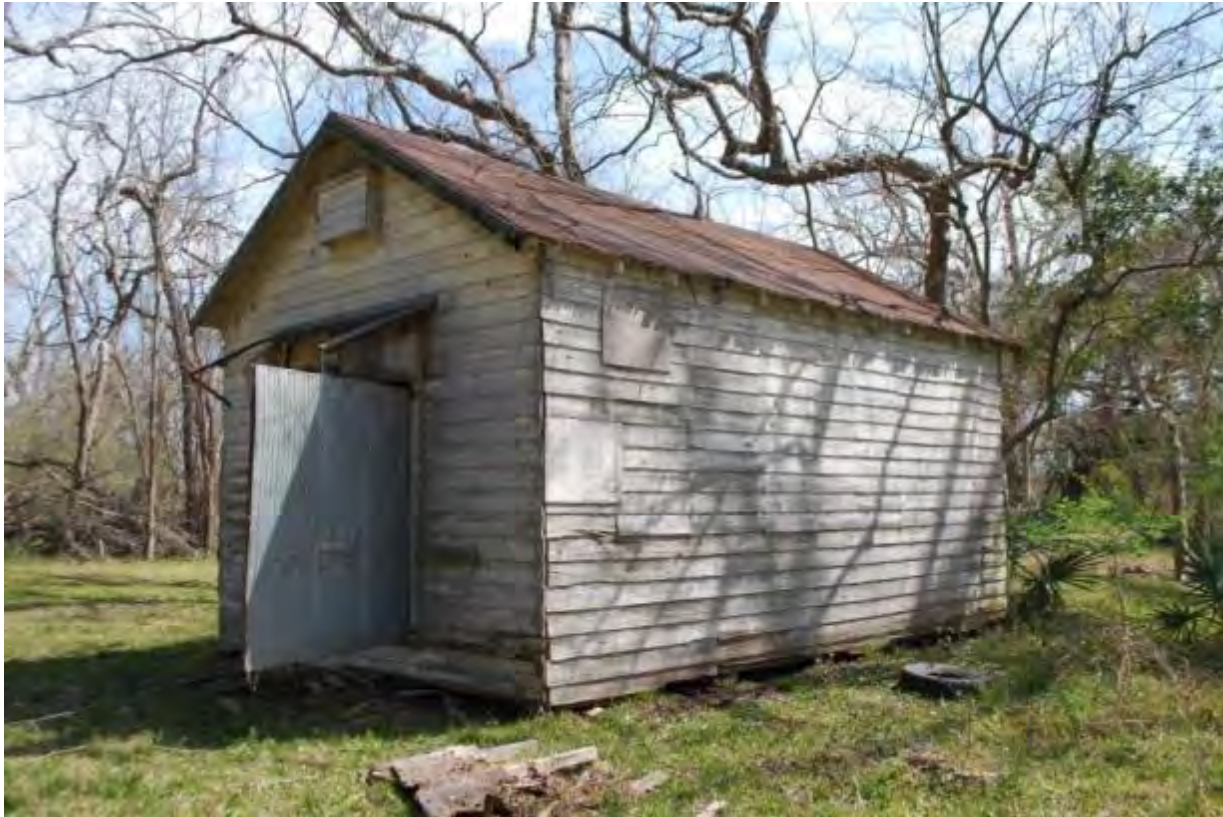
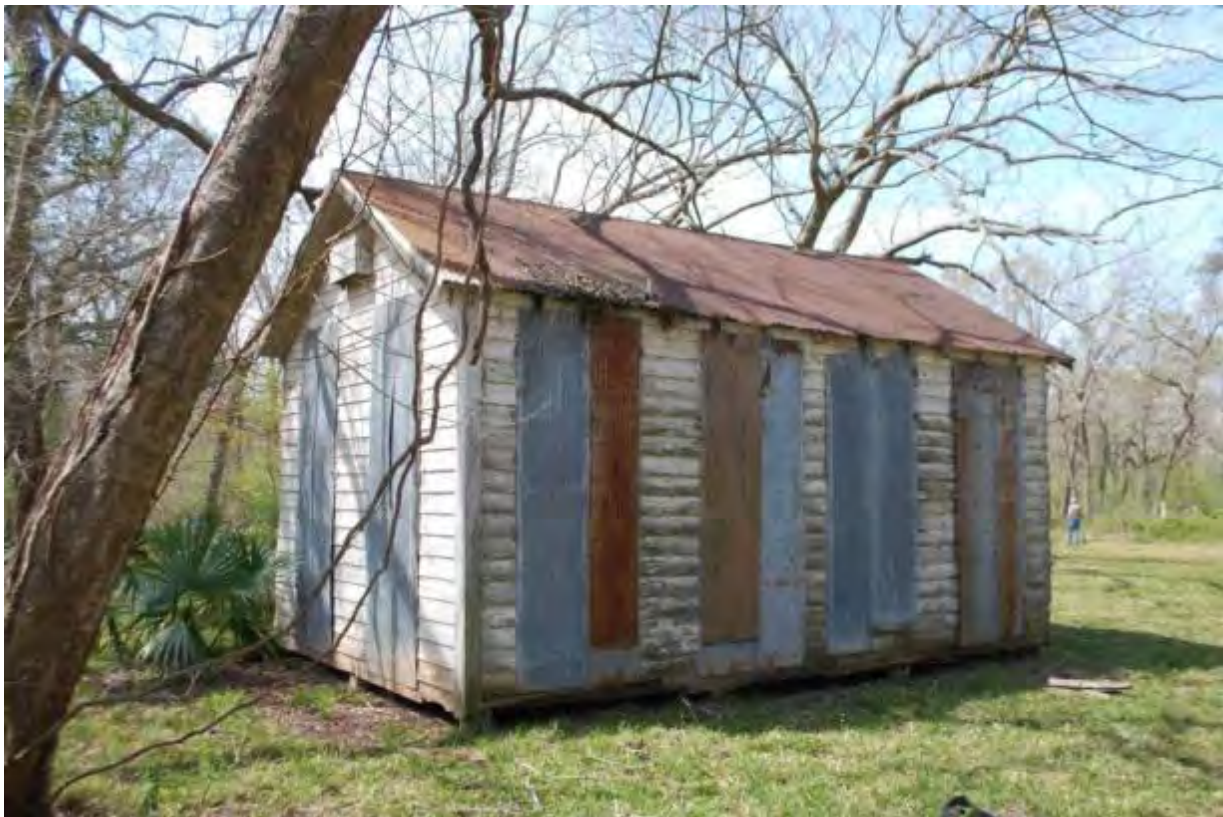
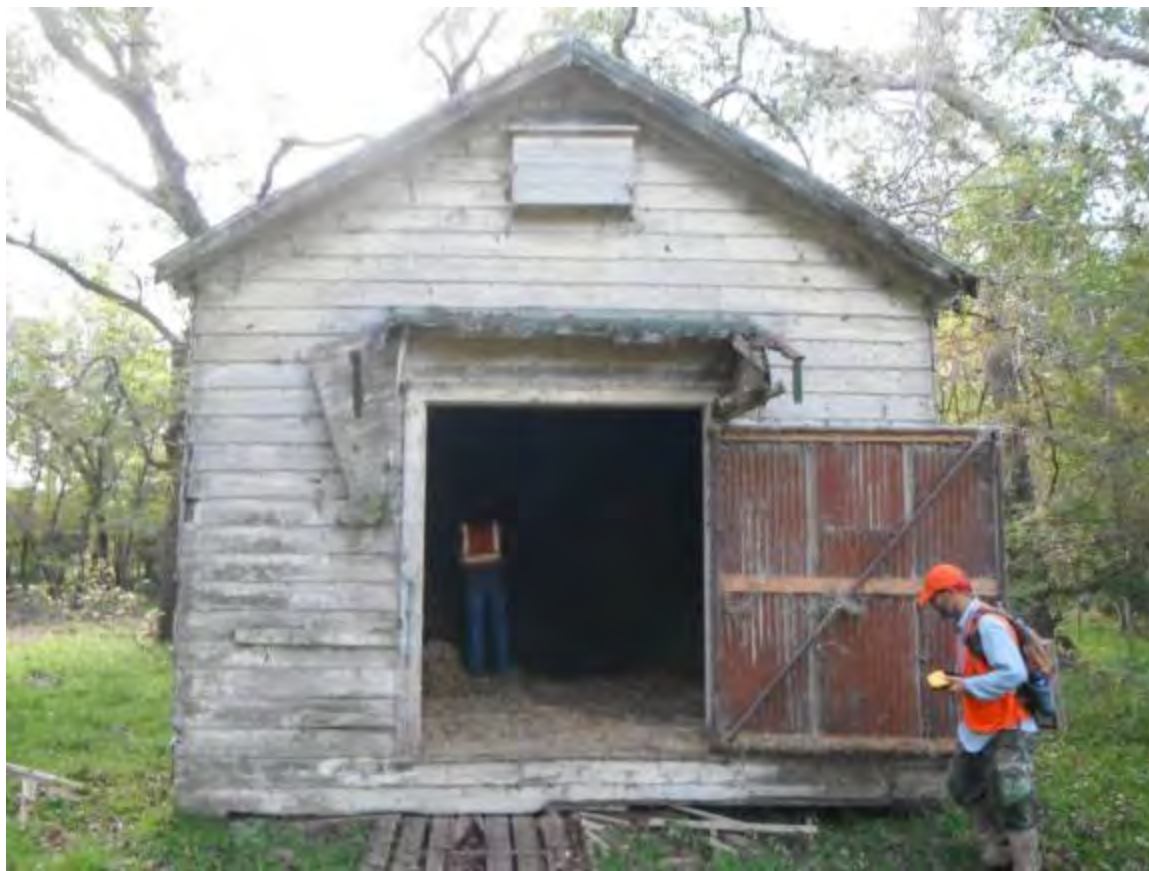
Comments: Small, rectangular plan, gable fronted one-by-four bay building with clapboard siding, exposed rafter tails, double door opening north facade and four evenly spaced window openings on side elevations and small, louvered vents in gabled ends. Former commercial (commissary) or institutional (school) building moved to this location for camp use. Currently used for hay storage. Building was moved here.

ID 4: North and east elevations, view SW

ID 4: North and west elevations, view southeast

ID 4: Rear (south) and east elevations, view northwest

ID 4: Front (north) facade, view south
