**CULTURAL RESOURCES SURVEY OF THE PROPOSED CHEVRON
PHILLIPS CHEMICAL COMPANY LP U.S. GULF COAST (USGC)
PETROCHEMICALS PROJECT IN [REDACTED],
BRAZORIA COUNTY, TEXAS**

SWCA Project Number 21457.01

SWCA Cultural Resources Report No. 2013-162

August 5, 2014

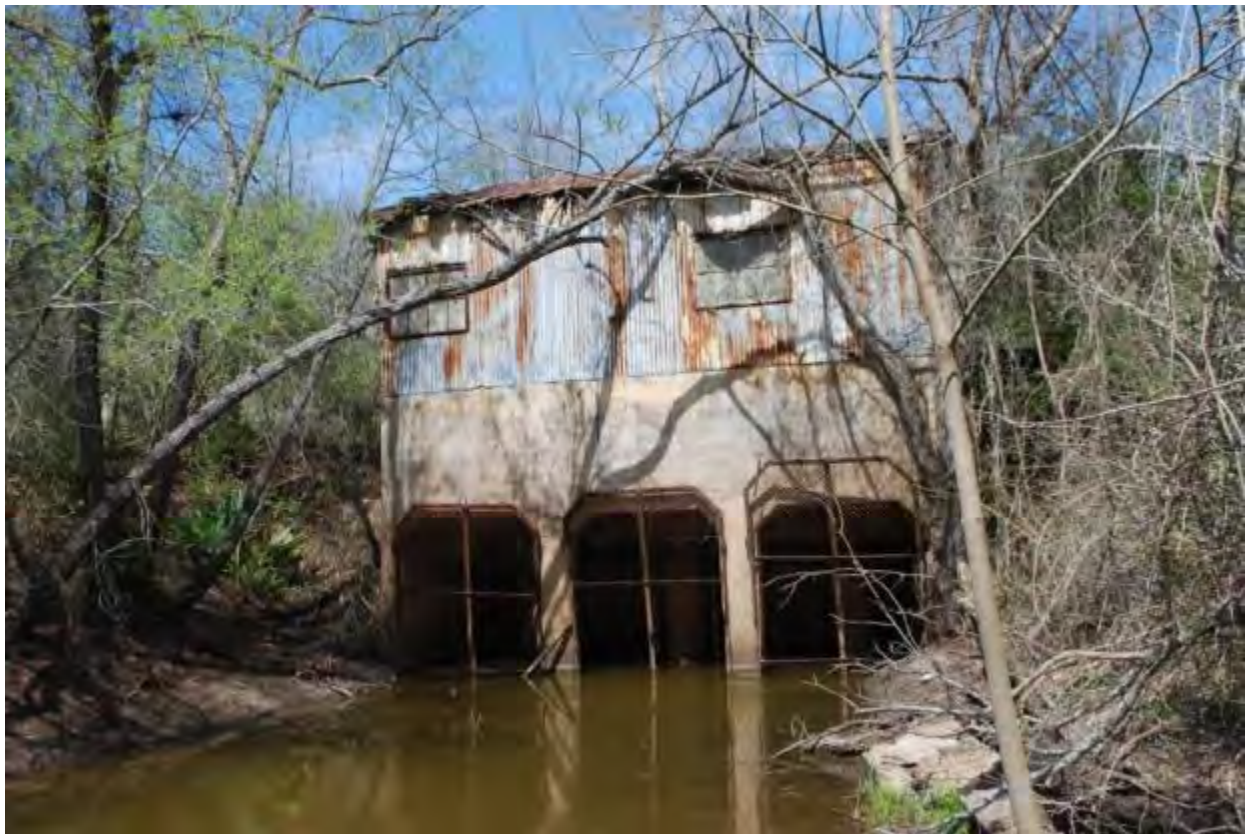
Comments: Pump house constructed over a manmade canal

ID 5: Pump house, north view

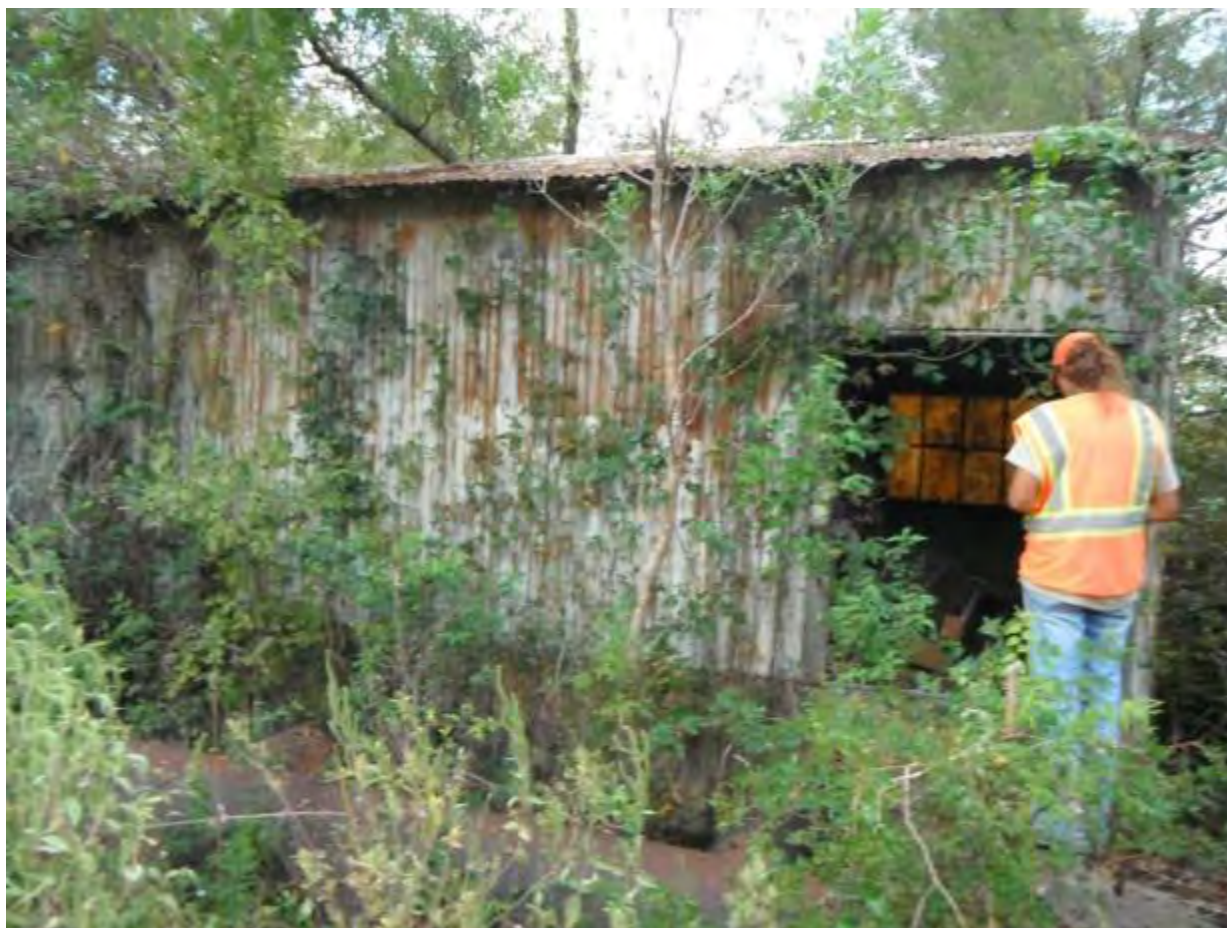
ID 5: Rear elevation of pump house, south view
