Archaeological Investigations at the Levi Jordan Plantation State Historic Site, Brazoria County, Texas

Archaeological Studies Report No. 7
CENTER FOR ARCHAEOLOGICAL STUDIES
Texas State University-San Marcos
2006

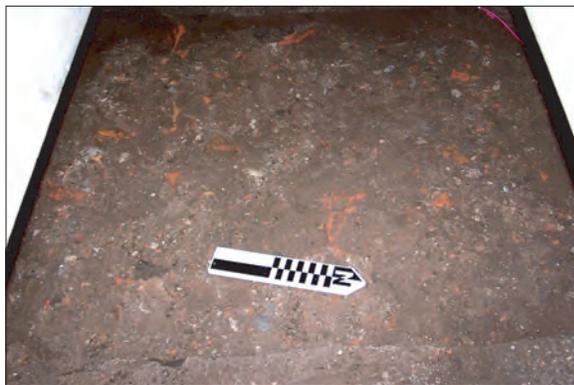
Figure 5-4. Photograph of Unit A5 level 1 (0–4 inbd) showing brick caliché terrace, facing west.

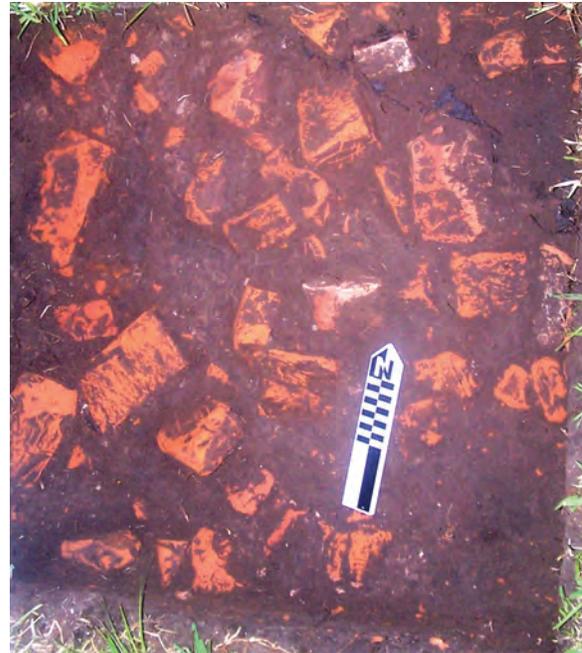
Figure 5-14. Photograph of Unit E2 level 2 (4–8 inbd), facing north.

Unit E2, located next to the current rear wing extension (see Figure 4-1), was excavated to a depth of 16 inbd. This unit was characterized by an overwhelming amount of brick fragments (Figure 5-14). There was indication of a previous excavation, lined with black plastic, in the northwest corner of this unit. At 16 inbd, a change in soil color was detected in the southeast corner. The soil change was labeled Feature 6, and was a well-defined square of a lighter brown soil that was very loose and soft (Figure 5-15). This 12x10-inch feature was excavated to 24 inbd. An eroded pipe was noted in the south wall profile at an

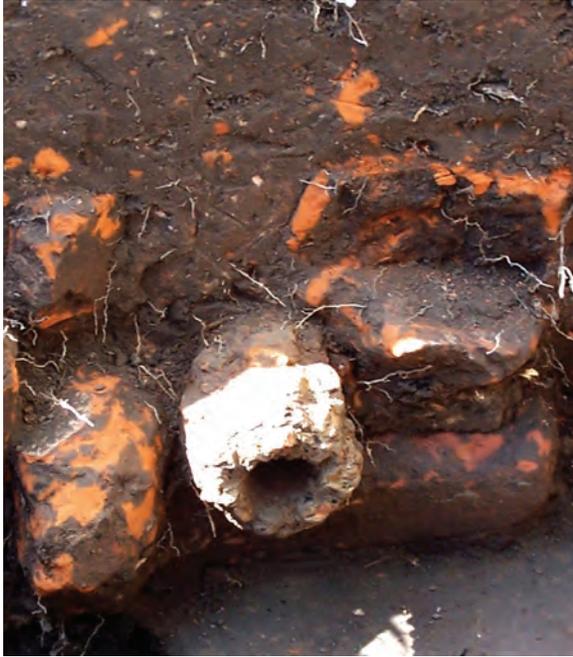
Figure 5-16. Photograph of eroded pipe in southern wall profile of Unit E2 at 10–12 inbd, facing south.
